Kodak Ngenuity Series Scanners Firmware Release Notes

Version 2.10.03 Summary (01-07-2013)

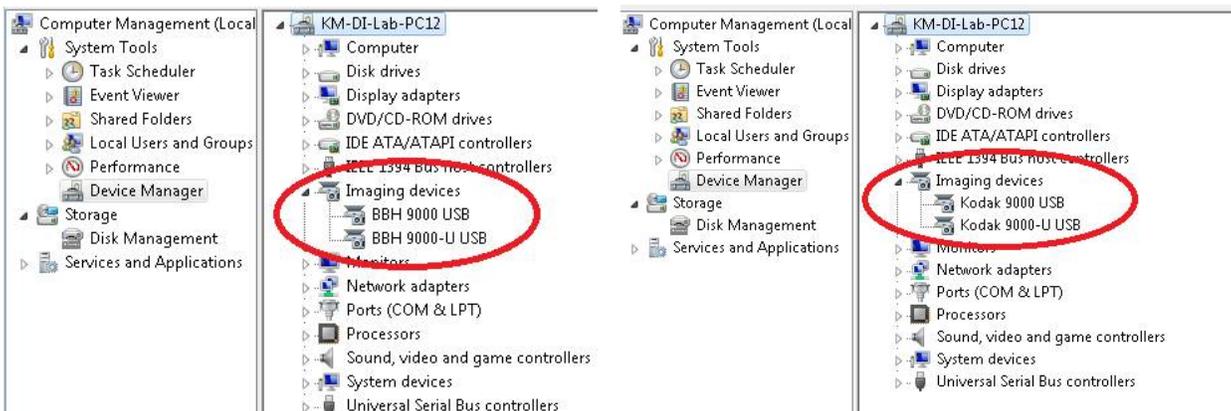
Version Details:

To determine if an Ngenuity scanner is BBH branded or Kodak branded open Window's Device Manager (Right-click on My Computer and select Manage and then select Device Manager from the left pane's tree structure. If the scanner name starts with "BBH" then it is Böwe Bell and Howell branded scanner. If the scanner name starts with "Kodak" then the scanner is Kodak branded.

The screenshot shows a window titled "Scanner Details" with the Ngenuity logo at the top. It is divided into two main sections: "Machine Controller" and "CGA".
